## The Niigata Flood in 2004 as a Flood Risk of “Low Probability but High Consequence”

Teruko Sato, Teruki Fukuzono, and Saburo Ikeda

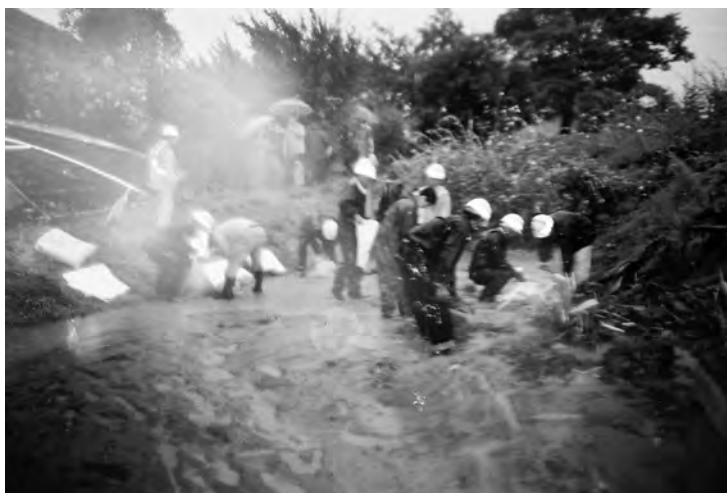
Photo 1. Flood-fighting activities to prevent water leakage of the levee.

Volunteer Flood Brigades made up of local communities was indispensable. Photograph 1 shows the flood control activities in progress.

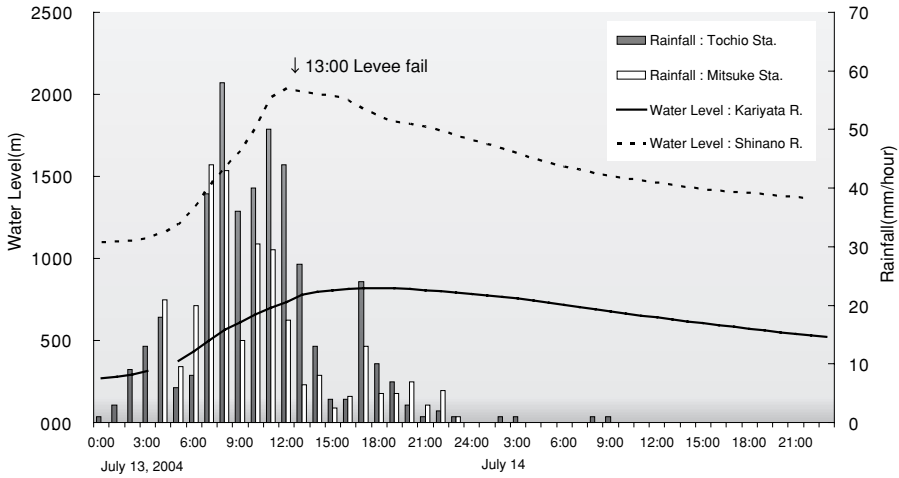
Fig. 4-1. Hydrographs of the Kariyata and Shinano Rivers and hourly amount of rainfall.

The cause of the 2004 Niigata floods was the inordinate amount of rainfall—both the total amount and rainfall over a short period of time—that was intensified by the seasonal rain (baiu) front that stalled over the region. The rain extended over the entire lower reaches of the Shinano River, and was especially intense over the drainages of the Ikarashi and Kariyata Rivers in the Chuetsu region. The headwaters of both rivers received 200–400 mm of precipitation over a 24-hour period (see hourly rainfall for the Kariyata River drainage in Fig. 4.1).

period would occur every 500 years, and 58 mm of rainfall in a 1-hour period would occur every 208 years (JSCE, 2004). Figures 4-1 and 4-2 show hydrographs for Mitsuke on the Kariyata River and Sanjo on the Ikarashi River, respectively. In the Kariyata watershed, the most intense rainfall of 58 mm/hour fell upriver on Tochio between 8 and 9 in the morning, but peak flooding did not reach Mitsuke at the foot of mountains until 1 to 2 in the afternoon, so there was a lag of about 4 hours between the heavy rainfall over the headwaters and the peak flooding that can be partly attributed to the water storage capacity of the upstream dam. In the Ikarashi River, the peak flooding reached the alluvial lower reaches after an 8-hour delay. If the flood arrival time is two times the time difference between the rainfall and when the peak flood flow appears, this yields a value of 8 to 16 hours. Thus the amounts of rain when the Niigata flood occurred were equivalent to a precipitation event that might occur once in approximately 500 years, and this concentrated torrential rain caused the water levels recorded at many of the observation stations along the rivers to break all previous records.

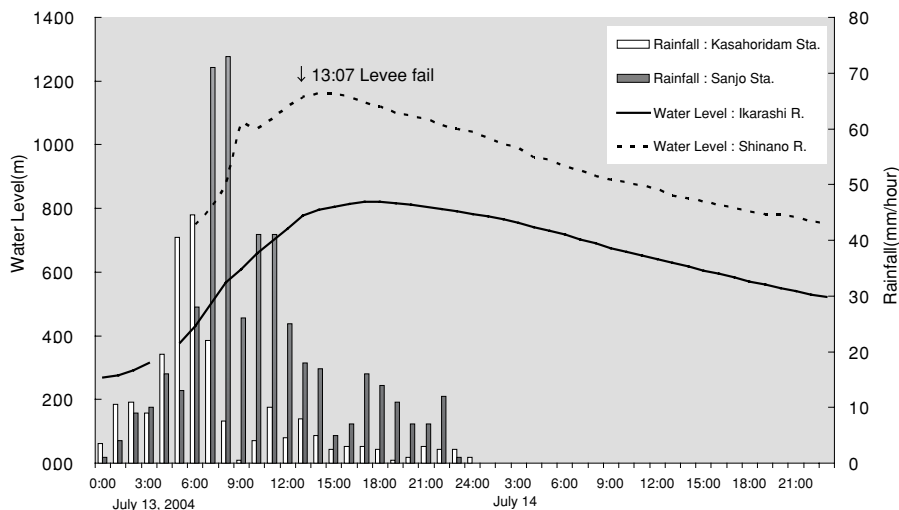
Fig. 4-2. Hydrographs of the Ikarashi and Shinano Rivers and hourly amount of rainfall.

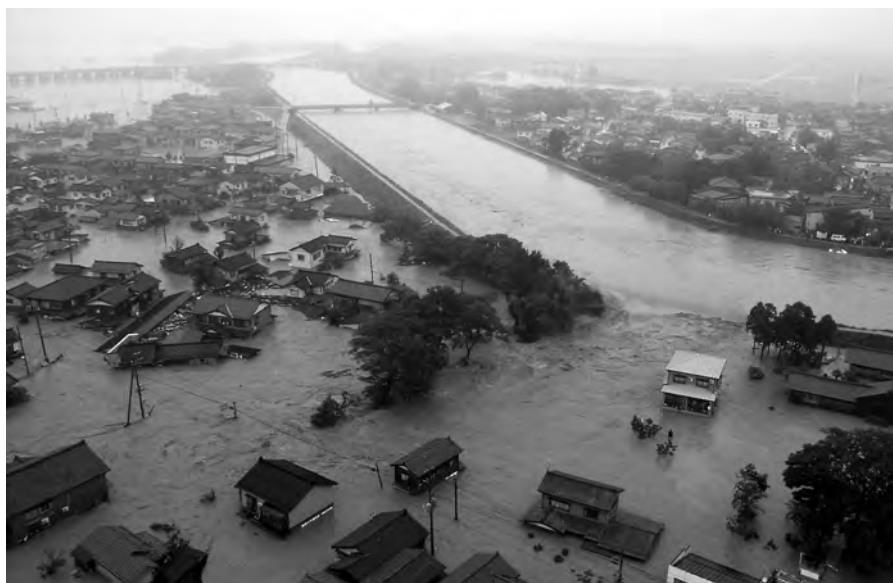
Photograph 2 shows the breach in the Kariyata River levee in Nakanoshima at 6:11 pm. The Buddhist temple Myoeiji that stood close to the breach has already been swept away, and houses in the area are submerged up to second floor level. Levees are intended protect the inland areas and communities behind them, but when they fail they expose these same communities to massive devastation from surging flood waters.

Photo 2. Flood water flowing into the housing area from the bank break site of Kariyata River (Photo by Kyodo-Tushinsha).
